Development of a Cavitation Erosion Resistant Advanced Material System

Project Report for the Modular Advanced Composite Hull form (MACH) Technology Project

November 2005

Report No. UM-MACH-RPT-01-05

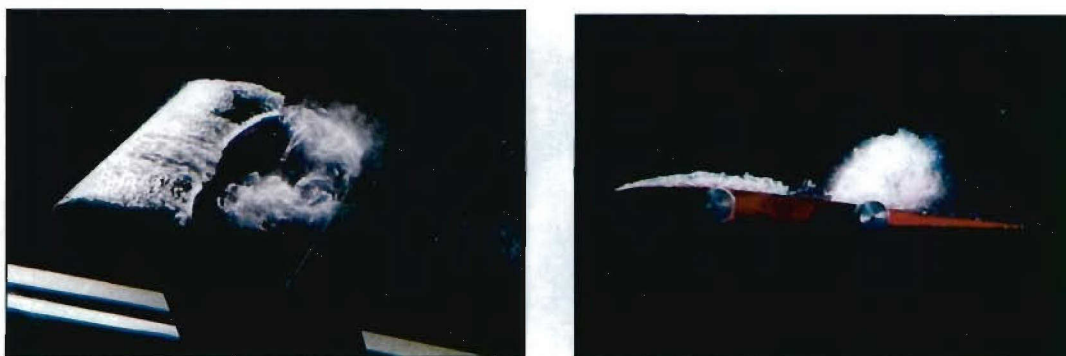
**Figure 1.1 - Photographs of cavitation generated by high speed lifting body shapes.
[University of Tokyo]**

There is a current need to evaluate the cavitation erosion resistance of materials and protective systems for advanced ship hull sections. Examples of the cavitation generated by moving bodies due to geometric shape changes are illustrated in Figure 1.1. The damage and material loss caused by cavitation erosion of naval surface vessels has traditionally only been seen in the areas of the propeller and rudder components. These components are typically constructed from relatively cavitation resistant materials such as stainless steel or NiAl (Nickel Aluminum) bronze. Both of these materials have a long history of being used in cavitating environments and are repairable when damage does occur. The downfall of these materials however is their excessive weight when evaluating these materials for the construction of a complete high-speed hull form. Most

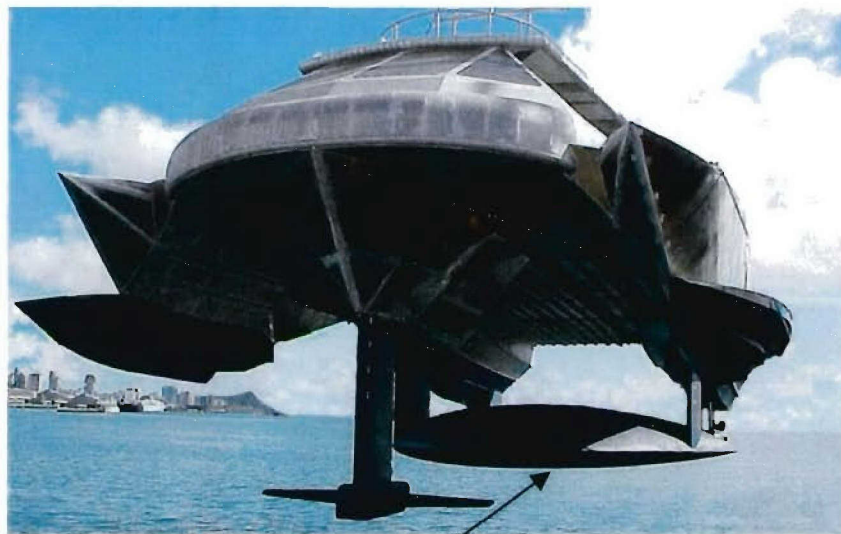
Parabolic underwater lifting body

Figure 1.2 - Midfoil Craft with Underwater Lifting Body

Figure 1.2 shows one example vessel called the MIDFOIL developed by Navatek where a hydrofoil and a parabolic lifting body shape are combined with a catamaran hull to achieve additional buoyancy and dynamic lift which greatly improves the performance and sea-keeping of the vessel. Relatively inexpensive pilot tests on the MIDFOIL and similar vessels have shown that this method has great advantage for fast military support craft and commercial vessels such as ferries. Recent studies have shown that the addition of underwater bodies can dramatically improve speed, reduce fuel consumption and increase payload. These efforts have also demonstrated that composite material construction can bring about increased structural efficiency.

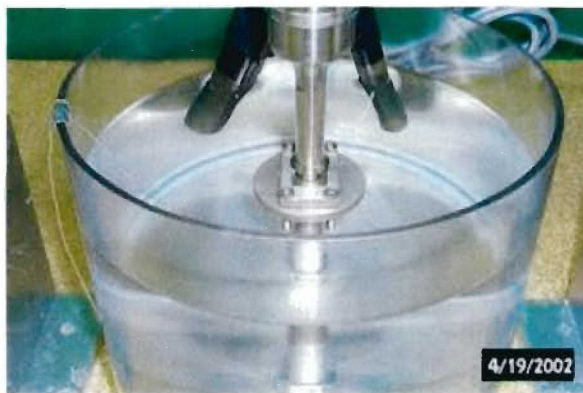
Figure 4.2 – Close-up photograph of the specimen holder

horn oscillates above the test sample at a precisely controlled distance and produces cavitation bubbles that impinge on the surface. The peak-to-peak tip displacement is OEM calibrated and adjustable on the amplifier. It is set to 0.050 mm for these tests. The test sample is mounted 0.50 mm away from the oscillating tip. Bulk fluid temperature in the container is maintained at 23-27° C by the use of a cooled water recirculation system. The temperature is monitored by a thermocouple in the tank. The erosion rate of the material is determined by periodically stopping the test and drying and weighing the sample. Weight was taken using an Ohaus Adventurer scale that has a 65g capacity and a precision of 0.0001g. The testing method is calibrated periodically using standard 6061-T6 Aluminum or Ni 200 as a reference material.

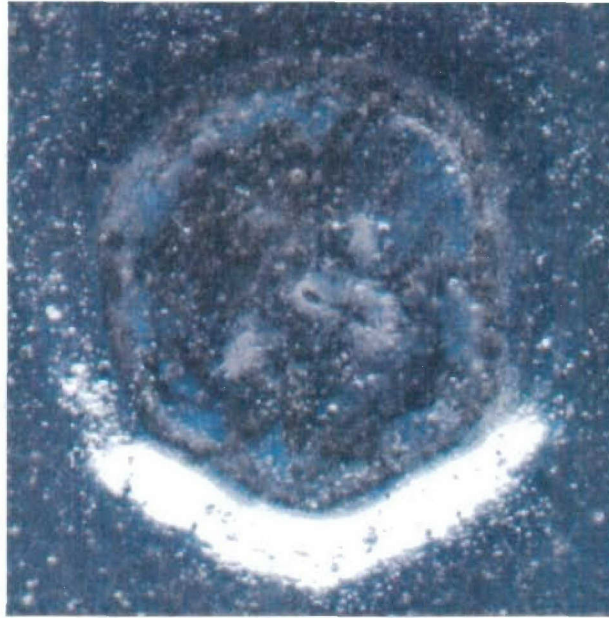
Figure 5.14 – Rhino Linings sample #110 showing typical damage including bubble formation under the horn tip

Rhino Linings® is a commercially available polyurethane truck bed liner from Rhino Linings USA, Inc. It is only available from licensed dealerships and is applied as a two-part spray. The samples were applied at the dealership onto an E-glass substrate. The average thickness was 0.0175". The average erosion rate from samples #137 and #138 was 22.4 $\mu\text{m/hr}$. The failure mechanism for this material was the formation of a bubble within the coating as shown in Figure 5.14. Dissection of the material revealed that the failure was caused by both delamination of the coating from the substrate and internal shear failure of the material.

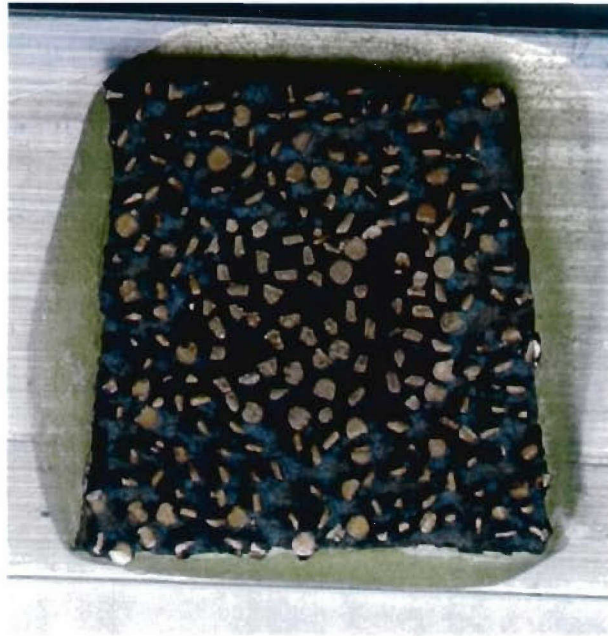
Figure 5.16 – Cuproprene sample showing damage to embedded copper-nickel granules

Cuproprene is manufactured by Dunlaw Engineering Limited and consists of a monolayer of cupro-nickel granules embedded and chemically bonded in a polychloroprene rubber sheet. The material is used primarily on submerged and splash zone structures for its anti-fouling capabilities. The material is available in sheet form and was bonded to an aluminum substrate using a two-part epoxy. The single sample erosion rate of $9.5 \mu\text{m/hr}$ represents mass loss in the cupro-nickel granules as shown in Figure 5.16. The rubber sheet showed little sign of cavitation damage.
